# 7 PREPARING FOR THE GREAT TSUNAMI

## UNEXPECTED HEIGHT OF TSUNAMI RESULTED IN SERIOUS DAMAGE

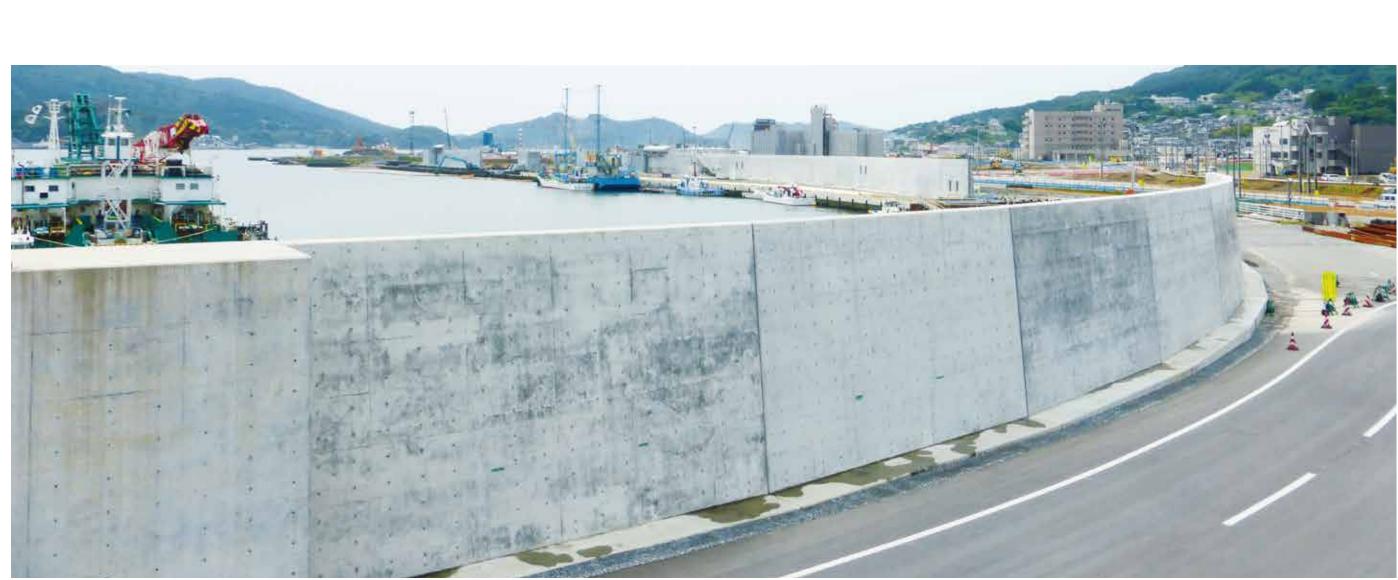
A seawall (7.5 m) in Ofunato Bay  $^{*6}$

The Japanese government decided to construct new, tougher seawalls and created new guidelines on the height of seawalls, which should resist a major tsunami occurring over the next several decades to 100-and-several decades\*3. Records of previous earthquakes were reinvestigated and the heights of the tsunami were estimated with computer simulations. Thus, new seawalls' heights were determined in each coastal region, which are 0-8 m higher than previous ones \*4. While constructions of the seawalls are ongoing, there are concerns that a huge seawalls may cause a deterioration in landscape, decrease in the size of sand beaches, or destroy the ecological system, to name just a few \*5.

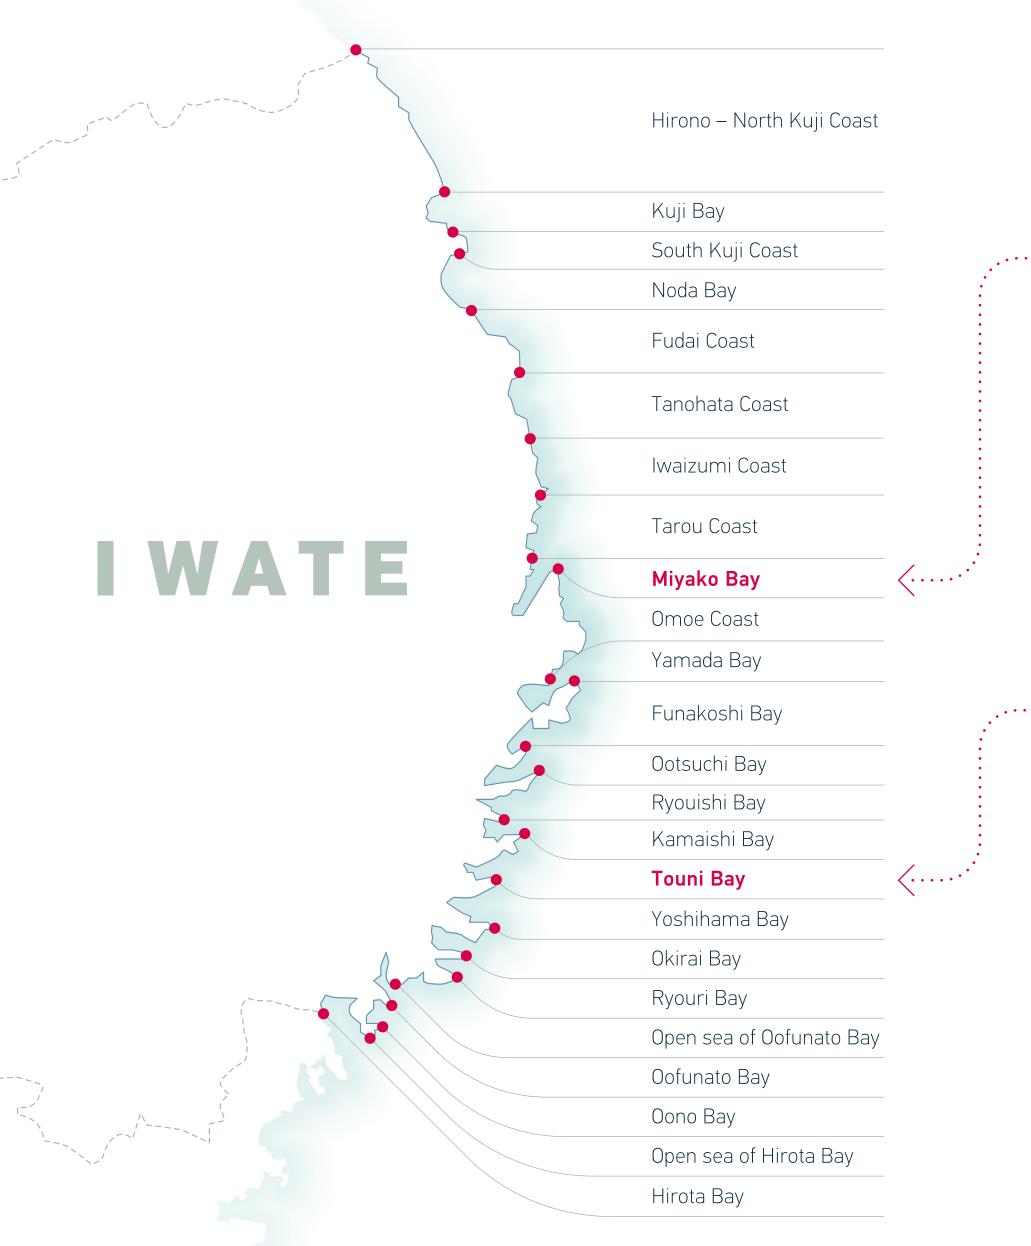
#### Method to determine the height of new seawalls in Iwate Prefecture

1933 Syowa Sanriku

**2011** Great East Japan Earthquake

▲ **1960** Chile

(Left) Twenty-four coastal areas, in each of which similar damage scales are expected if a tsunami hit. (Right) Estimates of the tsunami heights in two coastal regions due to past earthquakes, and determined heights of new seawalls.
